TECHNICAL REPORT ARCCB-TR-93036

**FATIGUE LIFE ASSESSMENT OF
155-MM M284 CANNON TUBES**

MICHAEL J. AUDINO

OCTOBER 1993

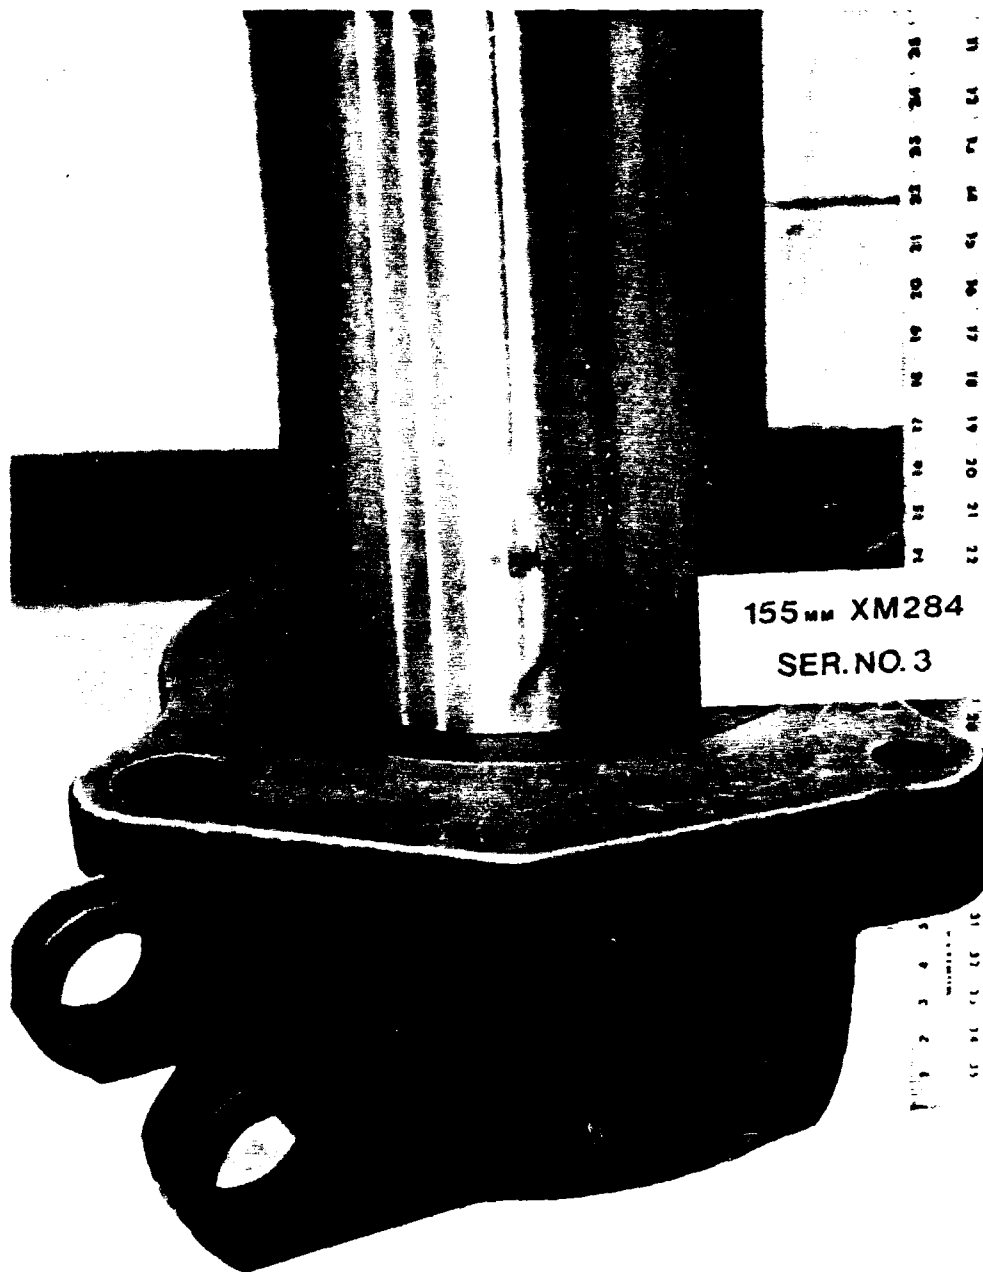
Figure 12. 155-mm XM284 Tube SN3 failure location.

Results from the seven-sample fatigue test are listed in Table 2. Results from the material property tests are listed in Tables 3 through 7. Figures 8 through 21 show the failure location and the fracture surface for each of the seven test samples.

As Table 2 demonstrates, four of the test samples failed in the torque keyway, while the remaining three samples failed in the charge notch region. Tube SNs 1, 5, 9, and 11 failed in the torque keyway. All of these tubes experienced uncontrolled, running cracks at the time of failure, as has been observed with 155-mm M185 tubes. Of the charge notch failures, Tube SNs 2 and 3 failed in a ductile mode with steady crack growth, while Tube SN825 experienced an unexpected running crack emanating from the charge notch and continuing to the breech face of the tube. There was no material fragmentation associated with any of the seven failures. Figure 22 illustrates the fatigue crack growth rate for the three tubes that failed from cracks emanating from the bore. All three curves show a similar critical crack depth, though Tube SN825 reached that crack depth much sooner than did Tube SNs 2 and 3.
